Manhole Inspection Summary

Manhole # S35QQ_020MH

Insp Date: 1/22/07 1:16 PM

Location Address: **318 25TH ST**

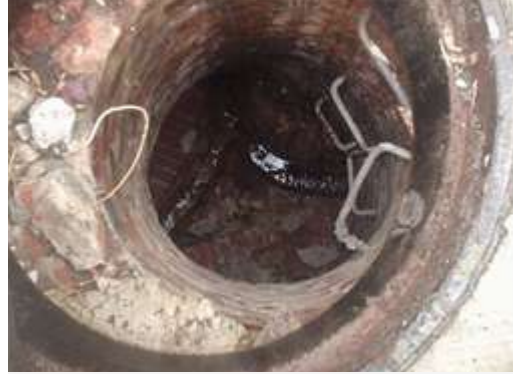
Top View

Adjustment root intrusion. Bench debris.

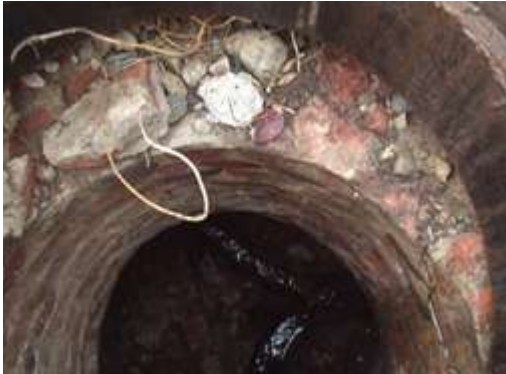
Defect

Frame leaks. Frame offset. Adjustment deterioration and infiltration.

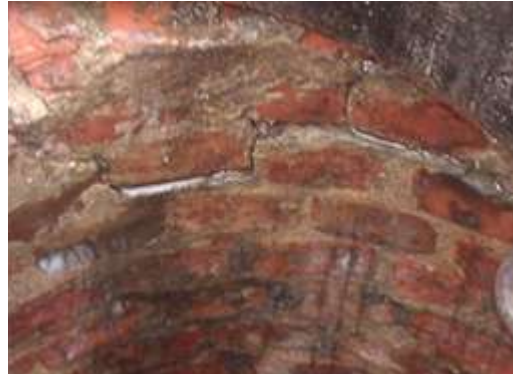
Defect

Frame leaks. Adjustment deterioration and infiltration.

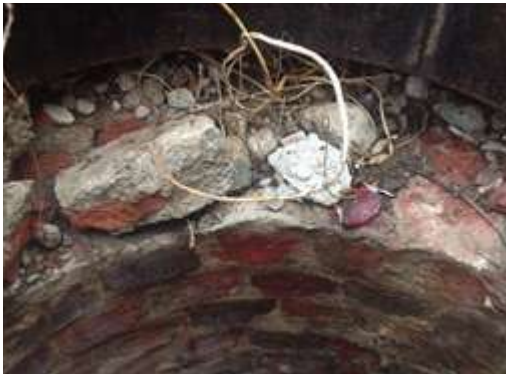
Defect

Frame leaks. Frame offset. Adjustment deterioration and infiltration.

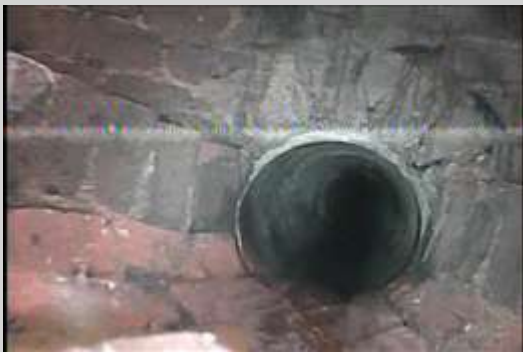
8 in. Circular Gravity Sewer Pipe Out @ 12 O'Clock

Infiltration: **Evidence** Pipe Seal Cond: **Cracked**

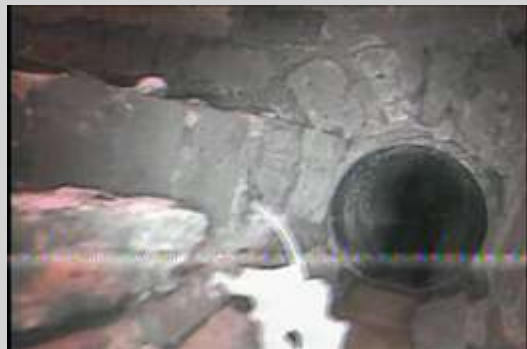
8 in. Circular Gravity Sewer

Channel deterioration.

Pipe Seal Cond: **Cracked**
